# Thermal Aging Assessment of Photovoltaic Cable Insulation Using XRF Spectroscopy

## Abstract.

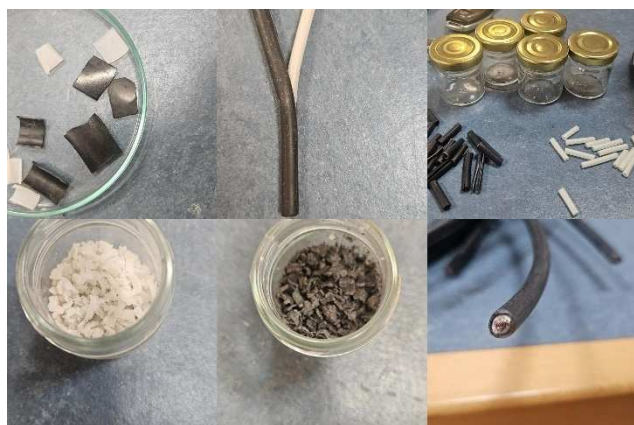
The preparation of insulation samples for thermal treatment and subsequent XRF analysis is shown in Fig. 1.

Fig. 1. Samples for thermal treatment and XRF analysis

For conventional cable insulation, the material was mechanically crushed and ground to a fine powder to obtain a homogeneous sample. This approach reduces the influence of local material inhomogeneities and enables a more representative analysis of the average chemical composition. The analyzed PV cable features a multilayer insulation system comprising an inner (white) and an outer (black) layer, each with distinct composition and function. To preserve the true structure of the insulation system, the PV samples were not ground but analyzed in their original form. The samples were mechanically prepared to achieve a flat, compact surface, ensuring stable contact with the XRF analyzer and improving measurement repeatability. Prior to measurement, all sample surfaces were thoroughly cleaned with alcohol to remove possible contaminants and minimize their influence on the measurement results.

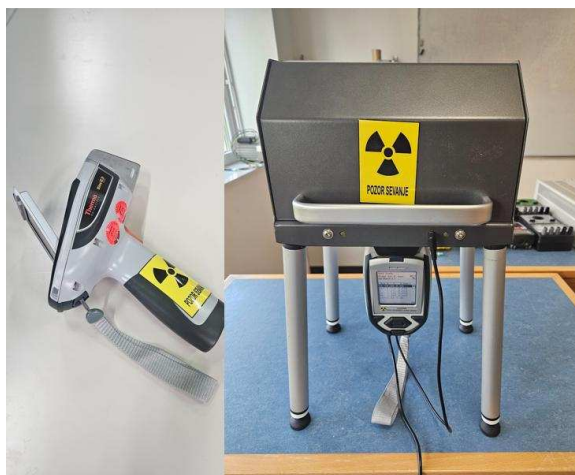
Elemental analysis of the insulation samples was performed using a portable energy-dispersive XRF analyzer (Niton XL3t GOLDD+). Measurements were carried out using a portable test stand (PTS), which ensured stable sample positioning and improved measurement repeatability. The experimental setup is shown in Fig. 3.

Fig. 3. Portable XRF analyzer (Niton XL3t GOLDD+) with PTS measurement stand used for stable and repeatable analysis of insulation samples

A measurement protocol optimized for polymer materials was used, focusing on the detection of halogens, particularly chlorine, and stabilizing elements such as calcium (Ca) and zinc (Zn), in accordance with the principles of quantitative XRF spectrometry.
